## MARINE SURVEY REPORT

**Report Number :** 2009S/1539  
**Date of Inspection :** August 2, 2009  
**Commissioned by :** [redacted] to photograph\*, document and determine the cause, nature and effect of a fractured bulkhead and related damages.  
**Address :** [redacted]  
**e-mail :** [redacted]  
**Phone :** [redacted]

The purpose of this inspection and survey report is to determine, insofar as possible within the limitations of visual and physical accessibility, through non-invasive and non-destructive means, the vessel's condition at time of survey by reporting deficiencies related to the fracture in the forward saloon bulkhead to starboard of the door.

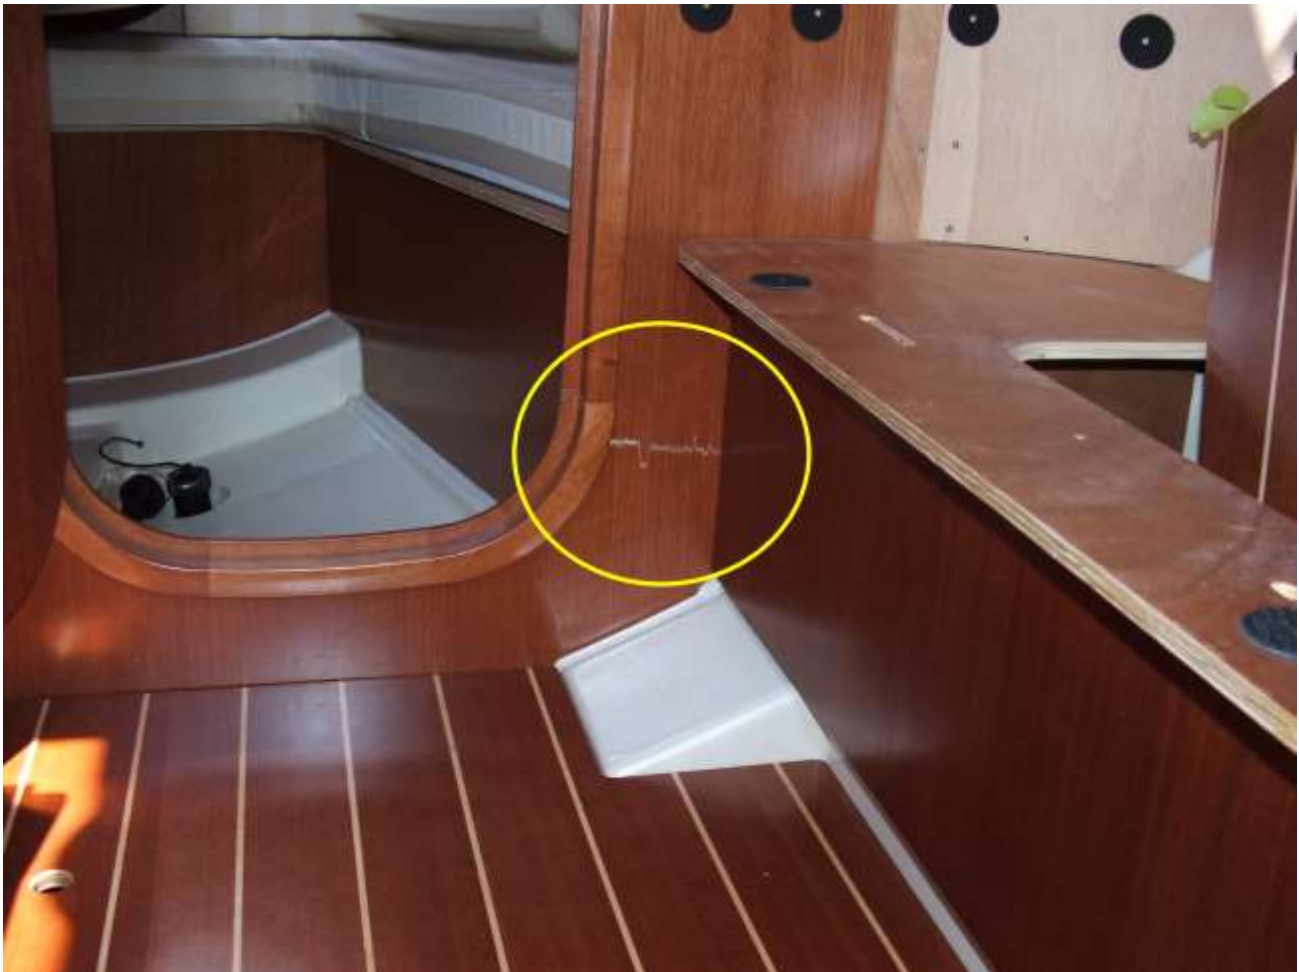
1. The forward saloon bulkhead to starboard of the door shows a horizontal fracture evident on both fore and aft sides of the bulkhead.

All joinerwork, cabinetry, wooden cover panels, side deckhead panels and any other wooden structure in contact with the forward saloon bulkhead and compression post should be removed to facilitate a closer inspection of the bulkhead and any supporting structure. Further and more invasive examination may be required.

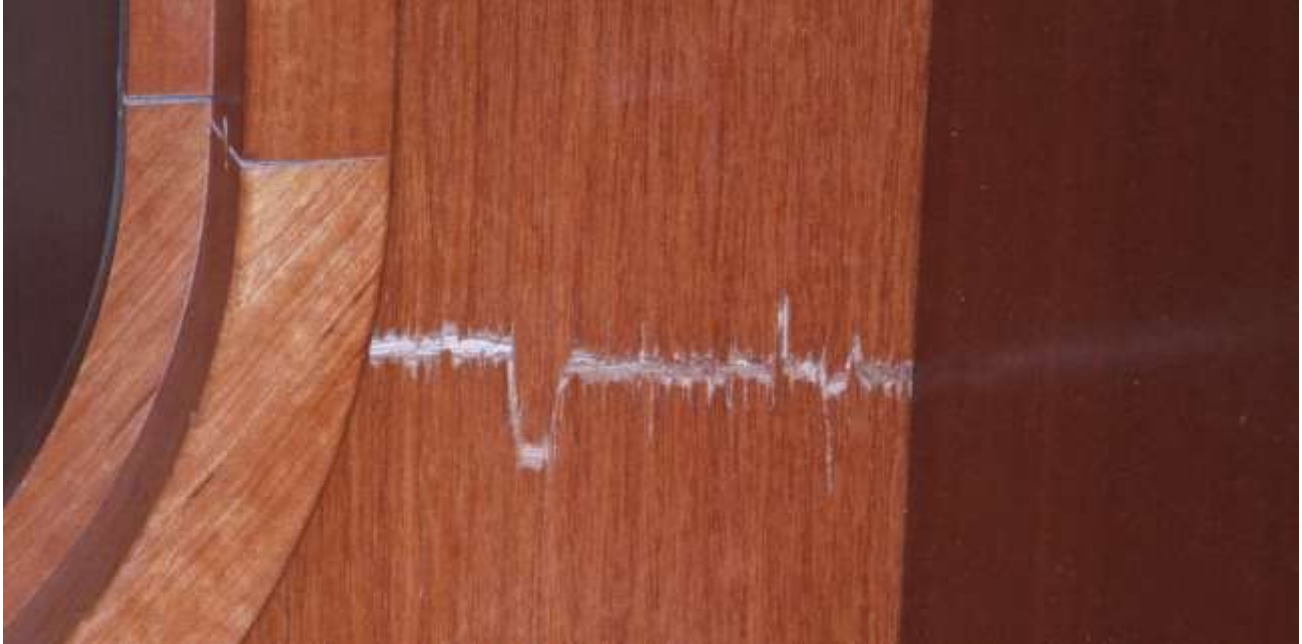
- 1b.** Bulkhead fracture close-up viewed from saloon. Note gap between door frame mouldings. A close up of this fracture will show vertical and slight horizontal movement along the fracture line.

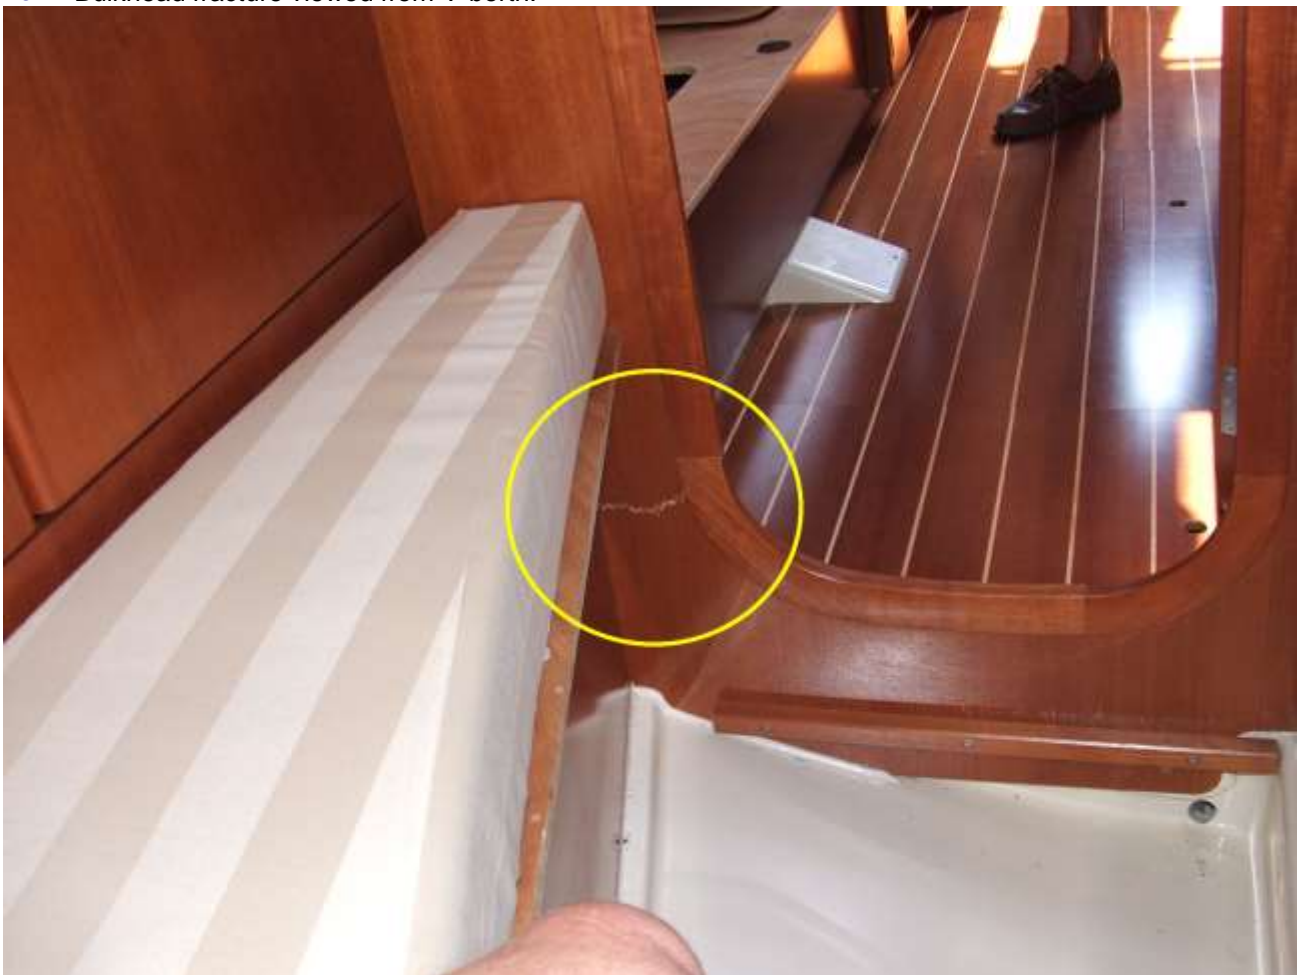
- 1c.** Bulkhead fracture viewed from V-berth.

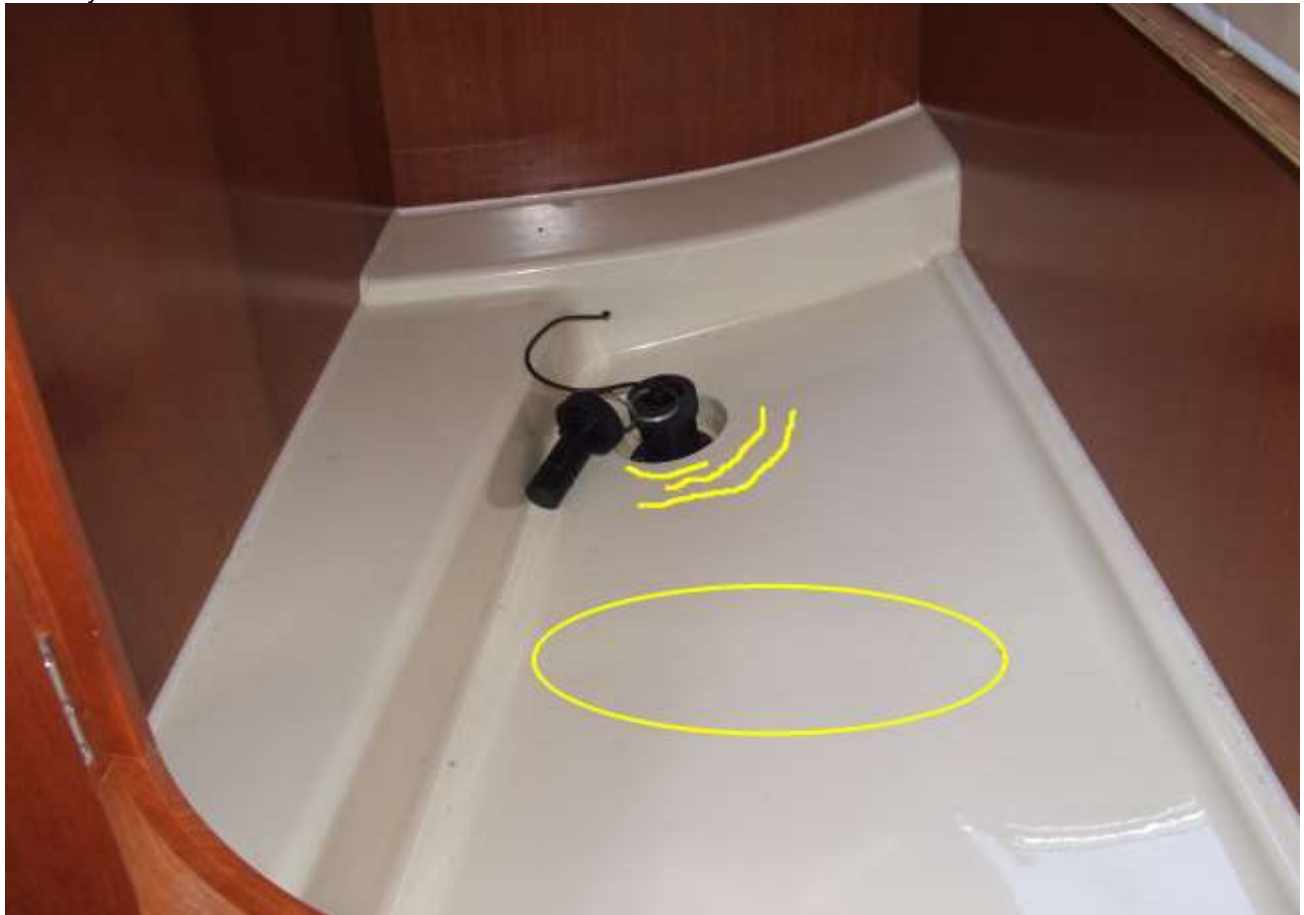
2. V-berth liner shows a 1" high buckle within the yellow oval. Generally radial fractures are noted around the cutout in the liner for the transducer as shown by the yellow lines.

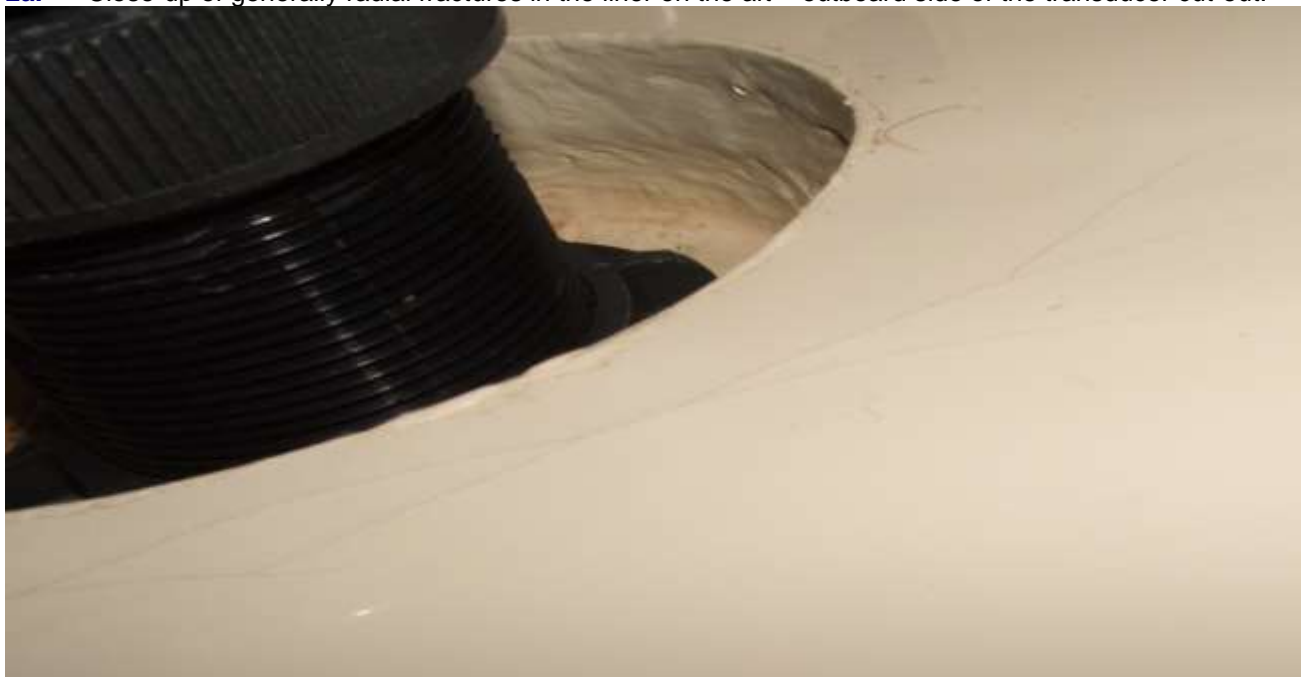
- 2a. Close-up of generally radial fractures in the liner on the aft – outboard side of the transducer cut-out.

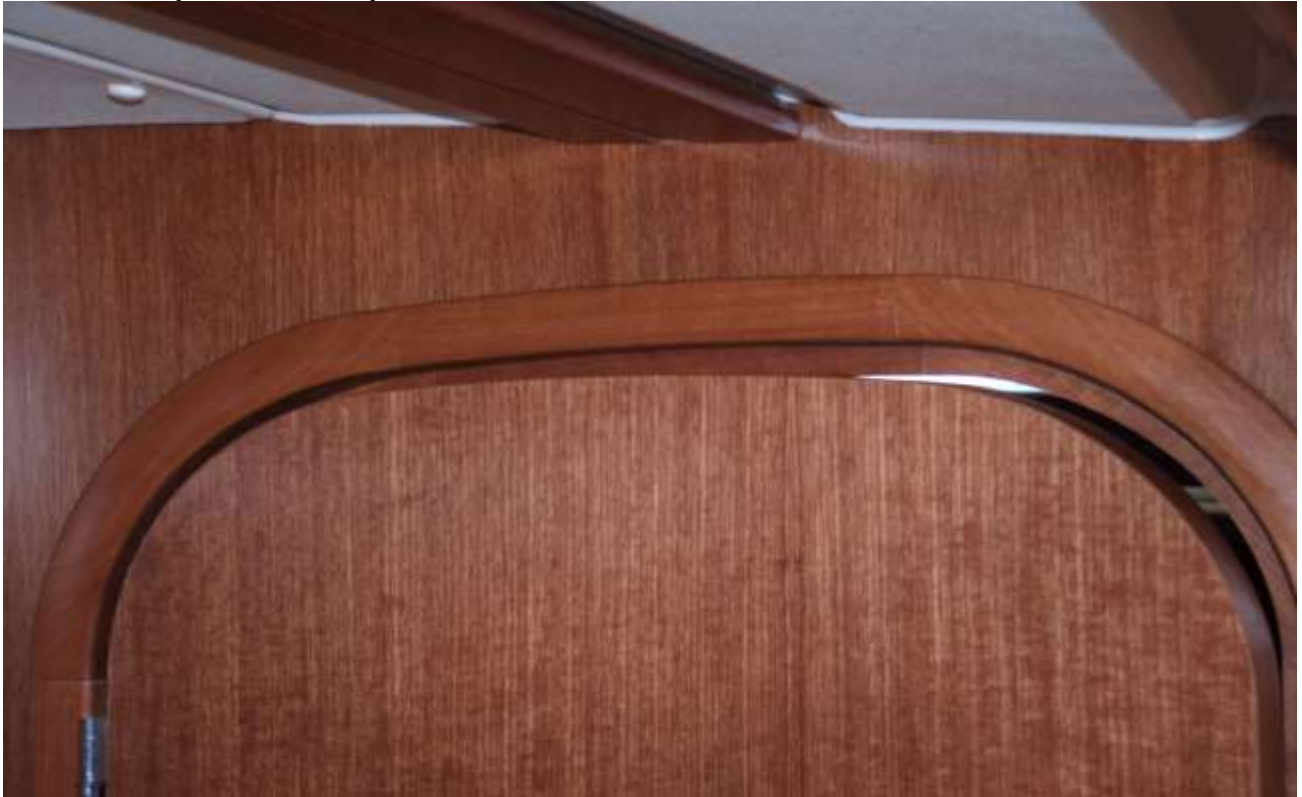
3. Top of saloon door viewed from saloon. Saloon door cannot be closed. Frame trim has shifted vertically and horizontally.

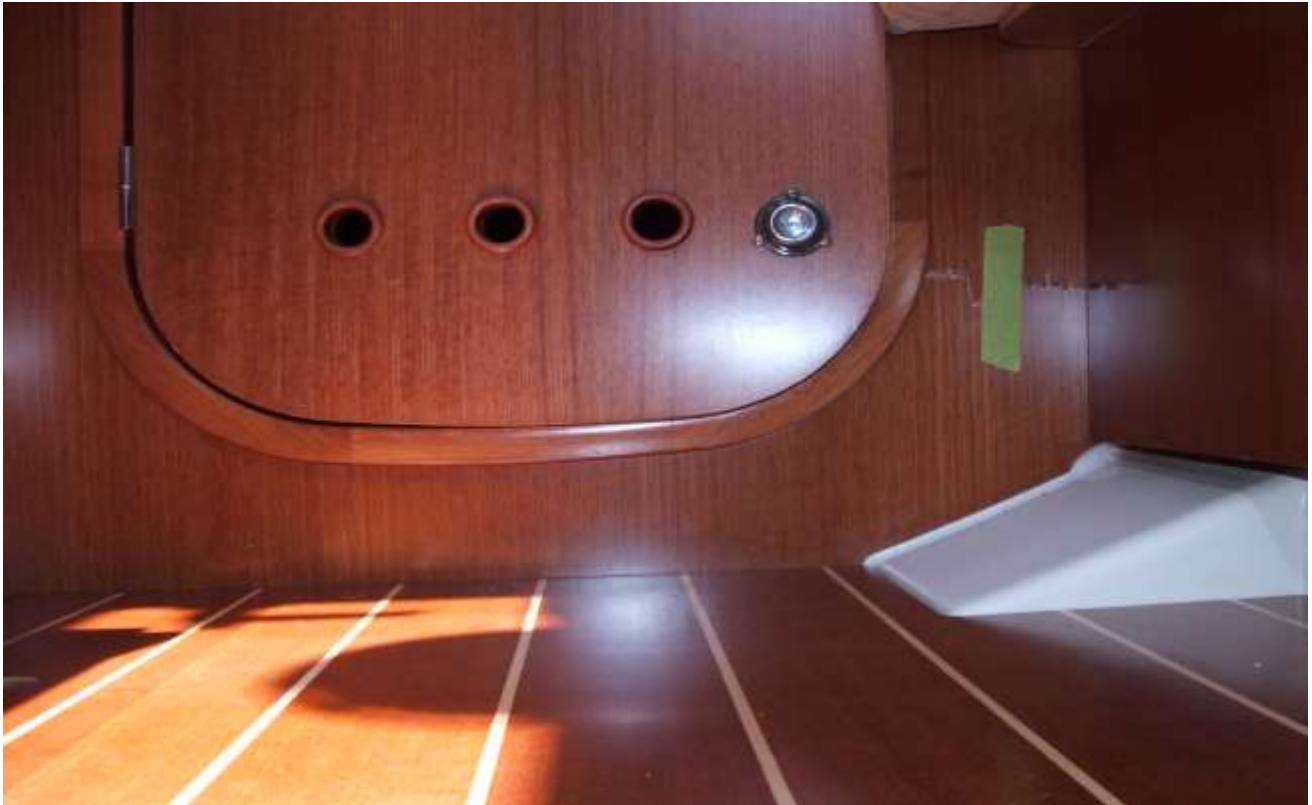
- 3a. Bottom of saloon door viewed from saloon.

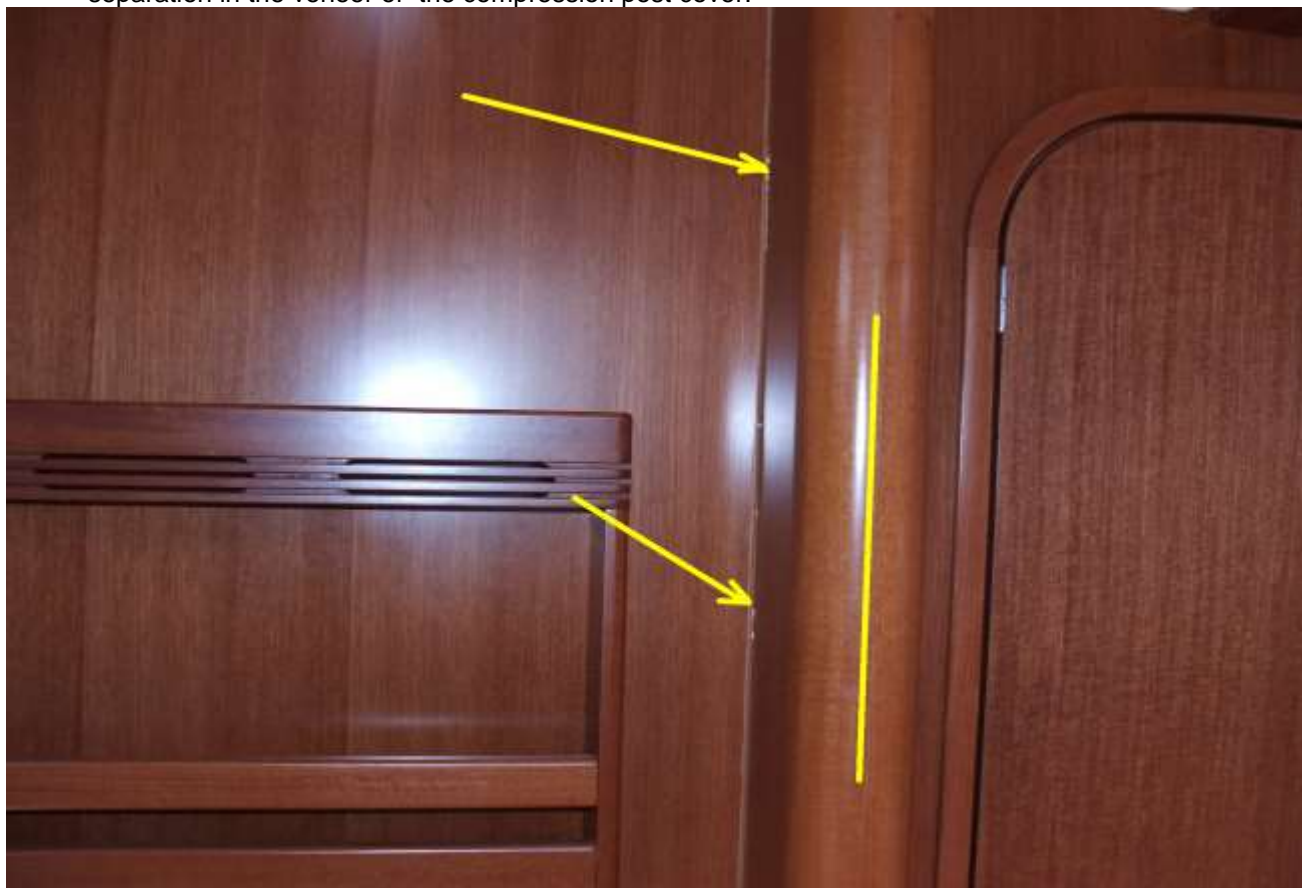
4. Saloon bulkhead and compression post cover viewed from saloon. Arrows show where the compression post cover caulking has separated from the bulkhead. The vertical yellow line shows a separation in the veneer of the compression post cover.

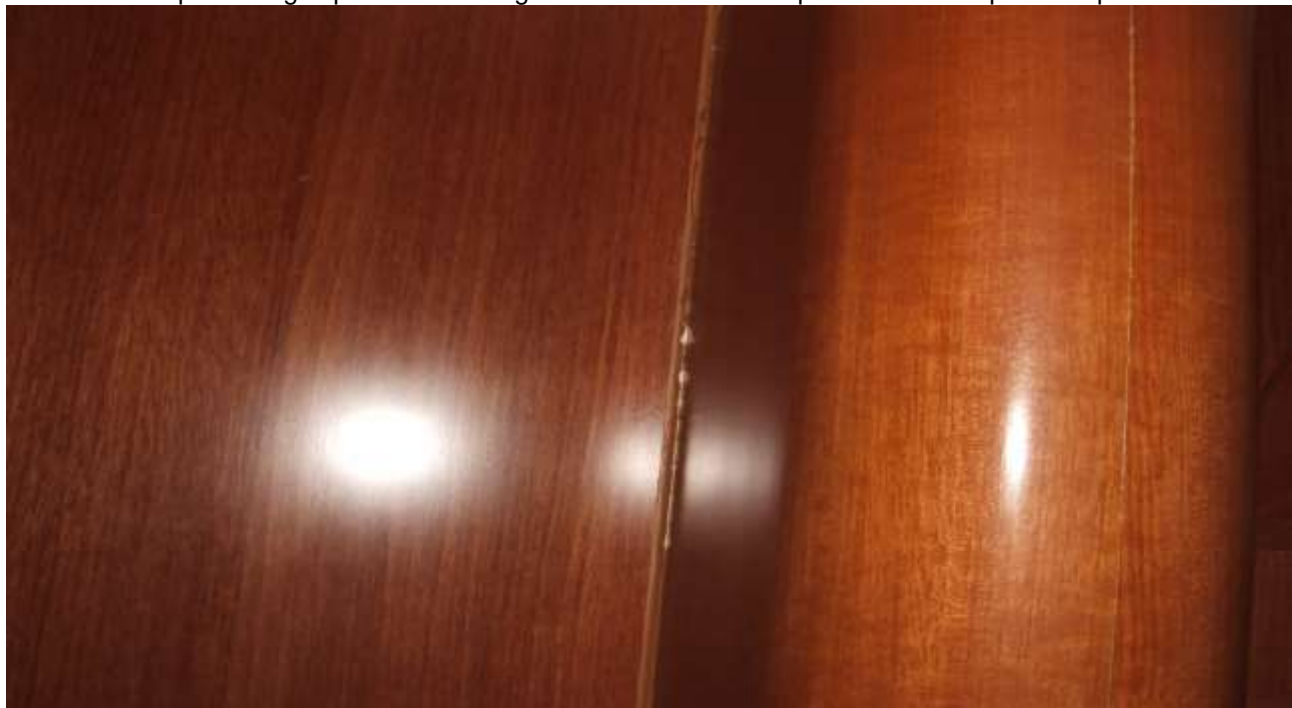
- 4a. Close up showing separated caulking and vertical veneer separation on compression post cover.

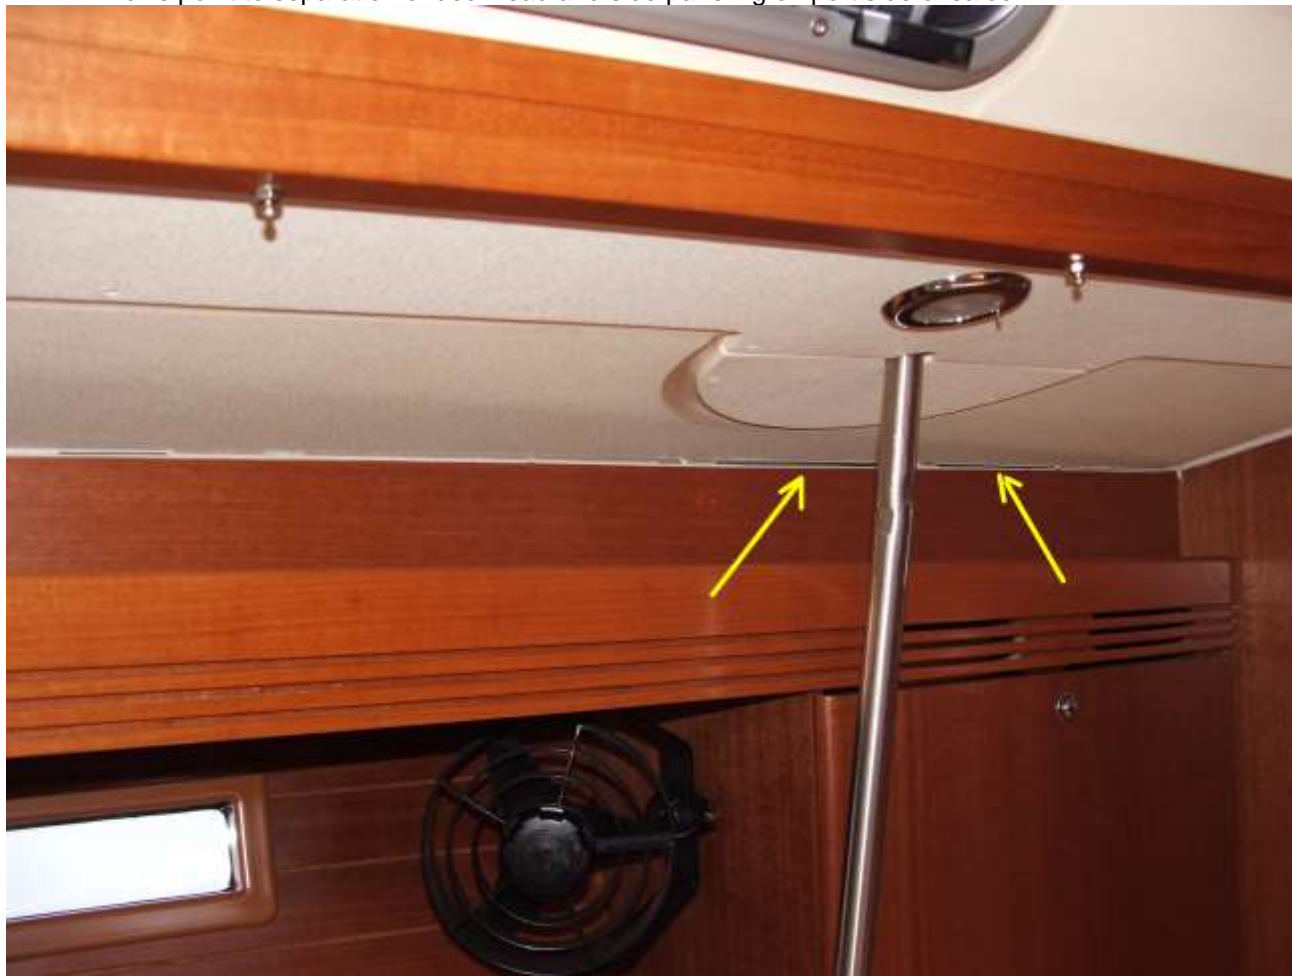
5. Arrows point to separation of deckhead and side paneling on port side of saloon.

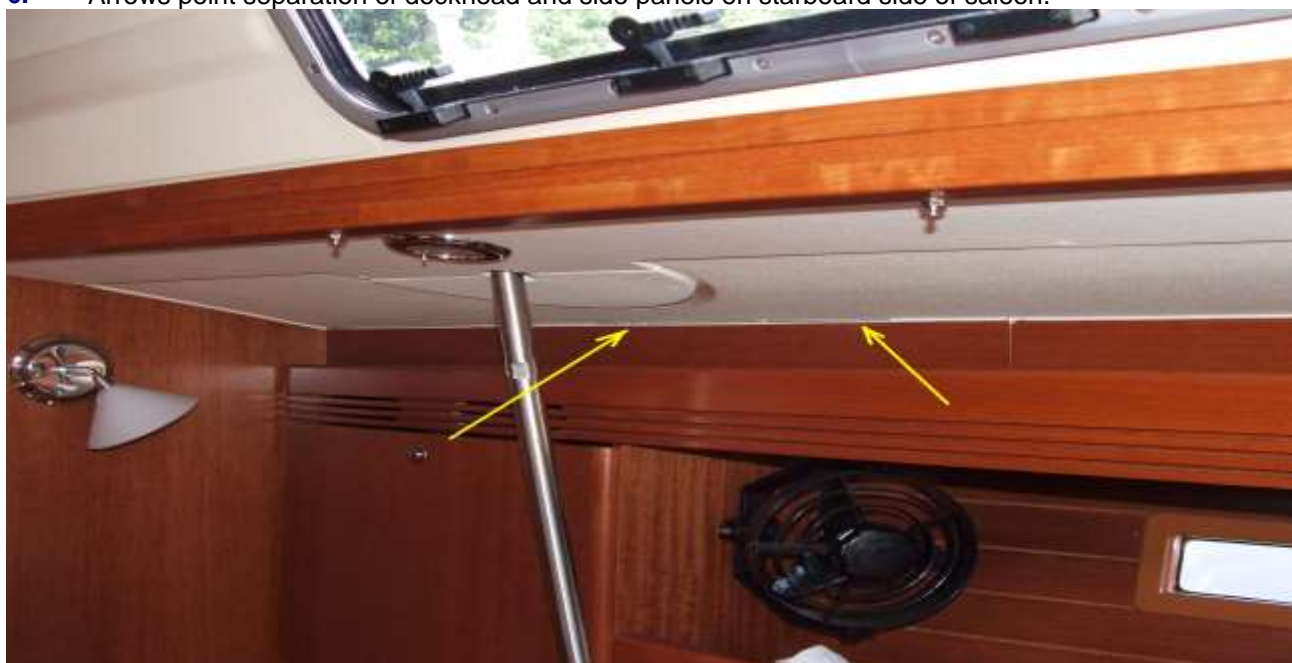
6. Arrows point separation of deckhead and side panels on starboard side of saloon.
