## MARINE SURVEY REPORT

**Report Number :** 2009S/1539C

**Commissioned by :** [REDACTED] to photograph\*, document and determine the cause, nature and effect of a fractured bulkhead and related damages.

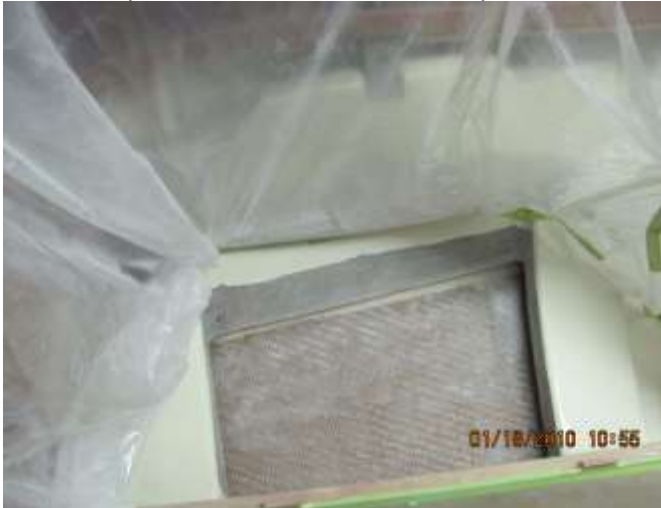
Starboard pan liner cut out, below chain plate,

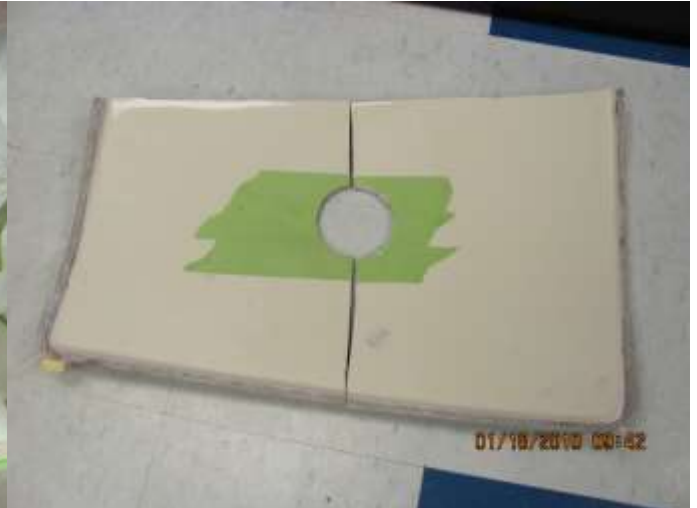
Pan cut out section

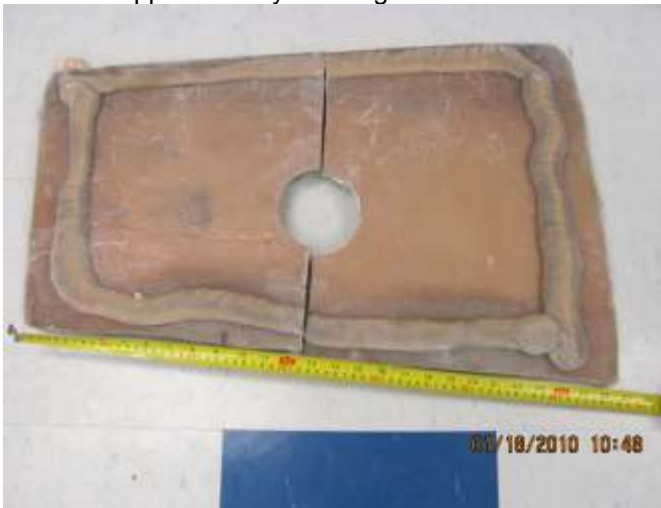
Cut out – approximately 26" long

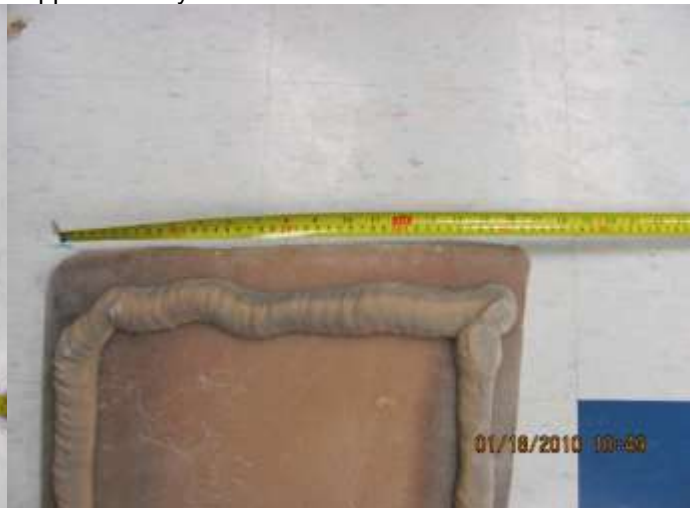
- approximately 17" wide

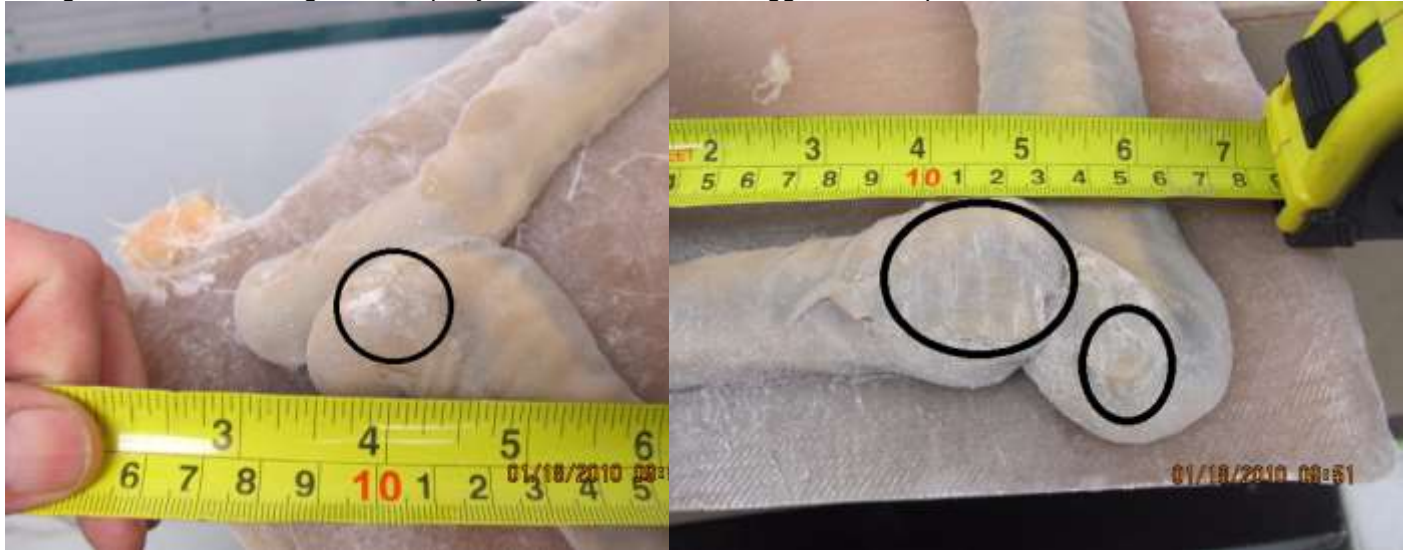
Of approximately 86" linear inches of bonding putty 1 1/2" wide, only about 3 square inches of the putty showed any indication of being in contact with the hull as shown by the three circled areas below. There was no sign of laminate tearing from the putty in these three areas suggestive of a poor bond.

Of approximately 129 square inches of bonding putty in the cut out section only about 3% was in contact with the hull. The bonding putty appears to be poorly mixed and improperly cured. Limited inspection suggests a similar condition on the port side.

Acquire from [redacted] the bonding putty pattern and determine through invasive techniques whether the rest of the liner is bonded to the hull as designed. A piece of the bonding putty should be examined by a qualified laboratory to determine its quality and whether it meets specifications to be provided by [redacted]. Further inspection using invasive techniques is advised to inspect the entire designed bonding putty contact areas.

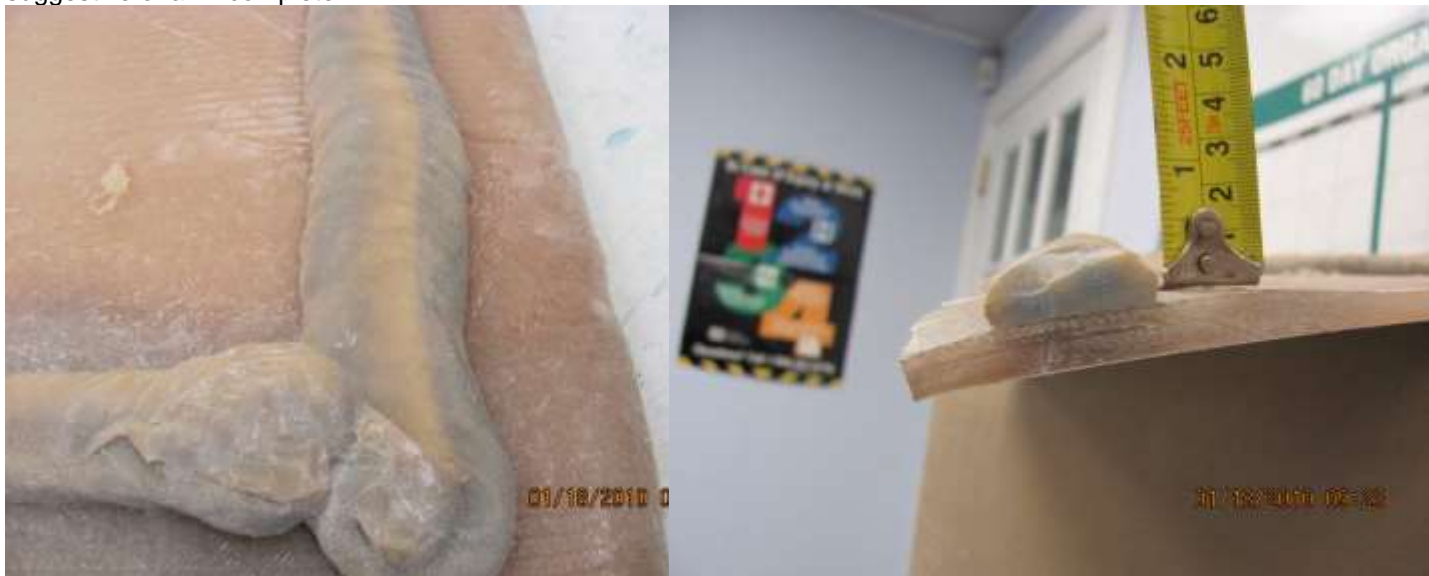
This bonding putty shows a wide variation in colour. Most bonding putties are colorized with consistent colour being an indication of complete mixing. This putty has a slightly tacky feel and a variable odour also suggestive of an incomplete mix.

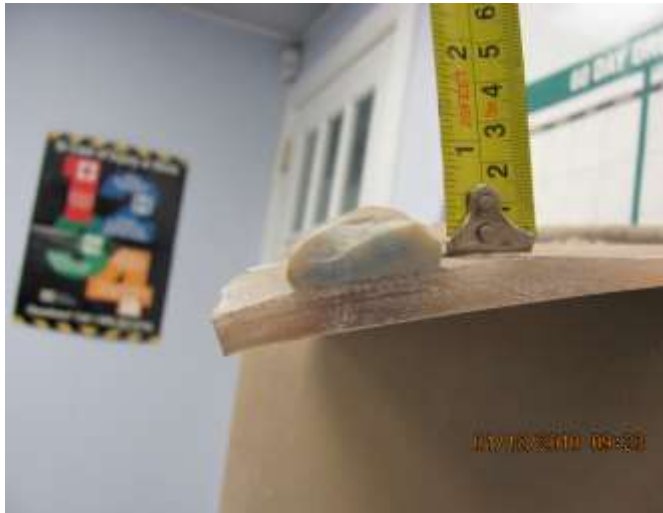
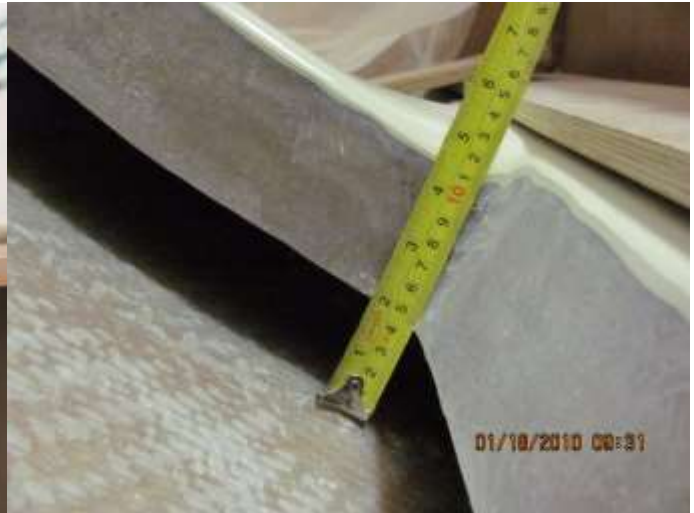
The bonding putty bead has an average thickness of approximately 1/2".

The gap between the liner and the hull is approximately 1 3/4".

Of approximately 129 square inches of bonding putty only about 3% was in contact with the hull.
