Marine Survey Report

Report Number : 2013P/2883
Date of Inspection : July 3, 2013
Commissioned by : [redacted] for pre-purchase purposes
Address : [redacted]
e-mail : [redacted]
Phone : [redacted]

Make of Vessel : Carver 310 mid-cabin express

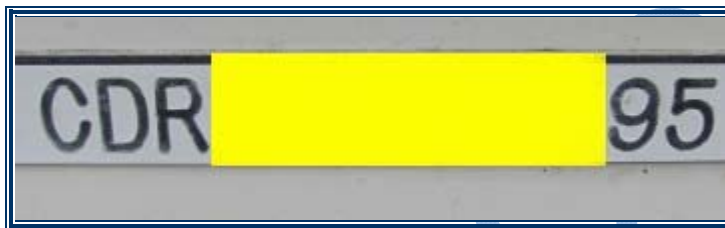
HIN/MIC on upper starboard transom

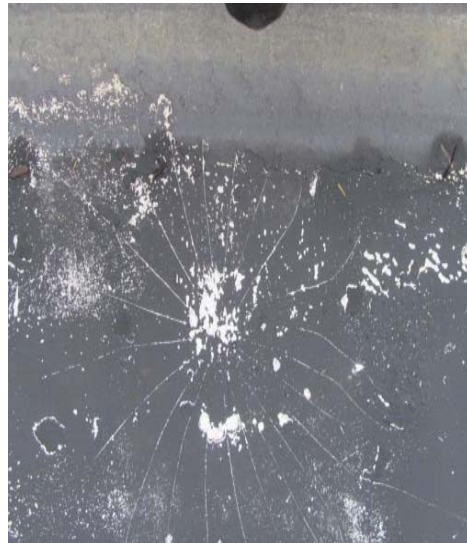
Transom : The transom checks sound with moisture levels in the low range above the waterline. An 18" star shaped fracture area checks sound. This is a cosmetic issue only as the transom is uncored.

18" star fracture on transom

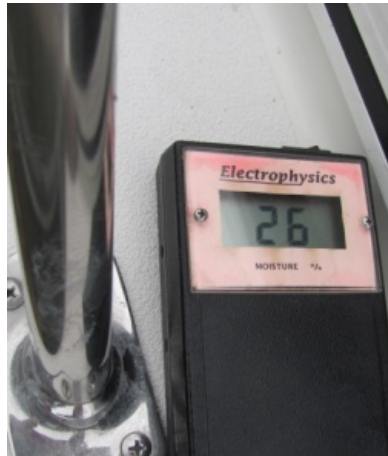
Both side and fore decks are highly variable as to moisture content and soundness. Moisture levels are elevated or high at all deck fasteners. With some corresponding areas of dull checking. **See comment (2).**

Port aft stanchion

1. Prepare bottom and renew anti-fouling paint.
2. Re-bedding horn, deck cleats and stanchion bases will help extend life of deck core.
5. Check all spark plugs for ease of removal and condition.

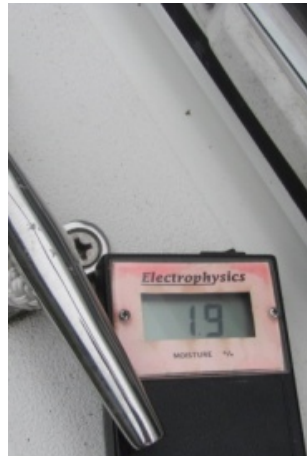
Port midship cleat

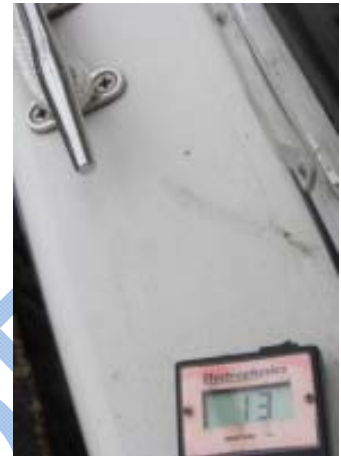
Aft of port midship cleat

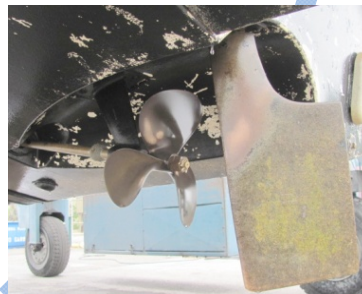
Port running gear

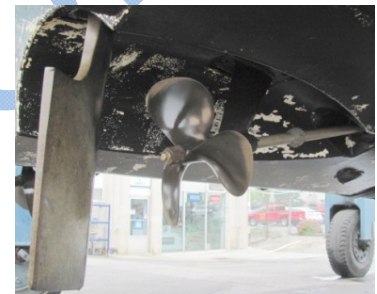
Stb. running gear

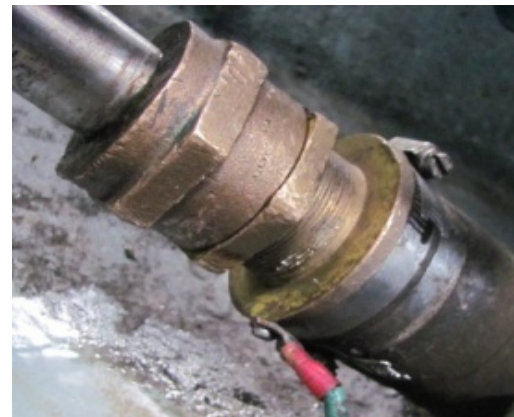
Shafting : Stainless steel shafts are secured cutless bearings to bronze through bronze struts with logs to conventional stuffing boxes. The port cutless shows very slight free play. Both stuffing boxes leak excessively at rest. The port unit leaks 3-5 drops per second while the starboard unit leaks a steady stream. **See comment (4).**

Starboard stuffing box

4. Stuffing boxes – re-pack or adjust as required.
- 12b. These batteries must be considered unreliable. Load test to confirm condition or replace.
- 17b. Close a/c intake ball valve and replace clear plastic strainer cylinder.

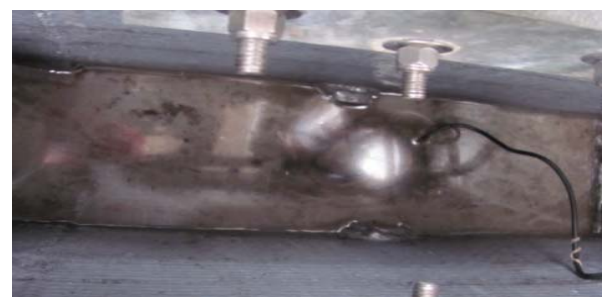
Although clean there was several inches on water in all bilges, (likely from leaking stuffing boxes) and the aft bilge pump ran continuously. A piece of a spark plug was found in the bilge under the starboard engine. **See comment (5).**

Water in engine bilges

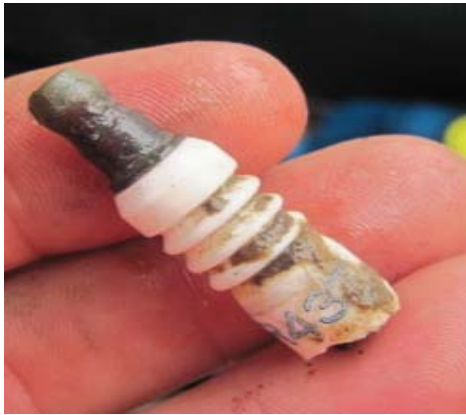
Broken spark plug

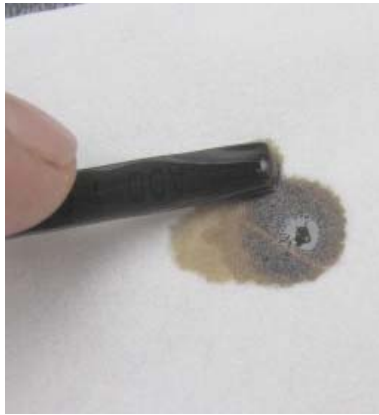
Port engine oil

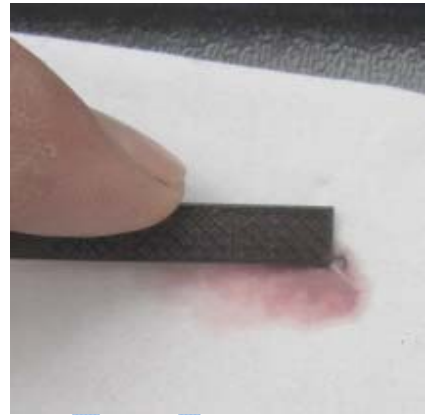
Port gear fluid

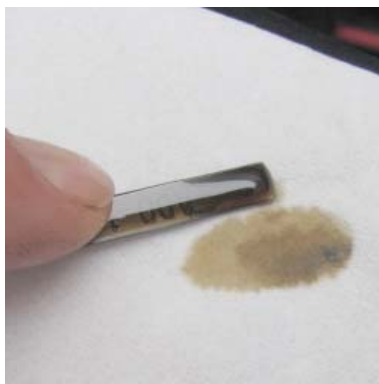
Starboard engine oil

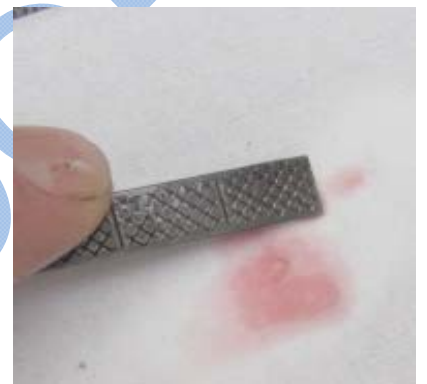
Starboard gear fluid

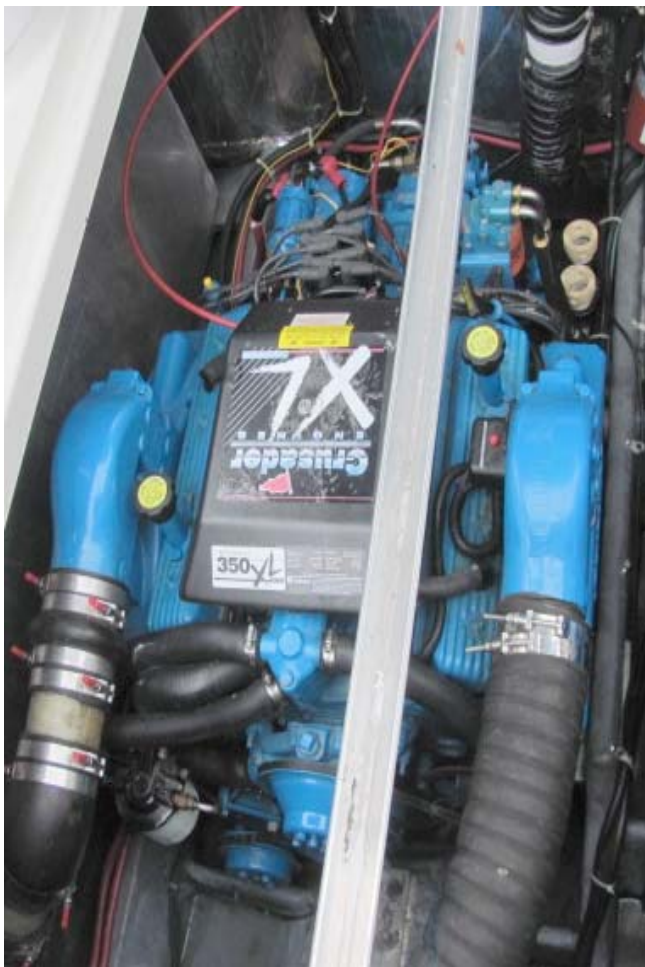
Port engine

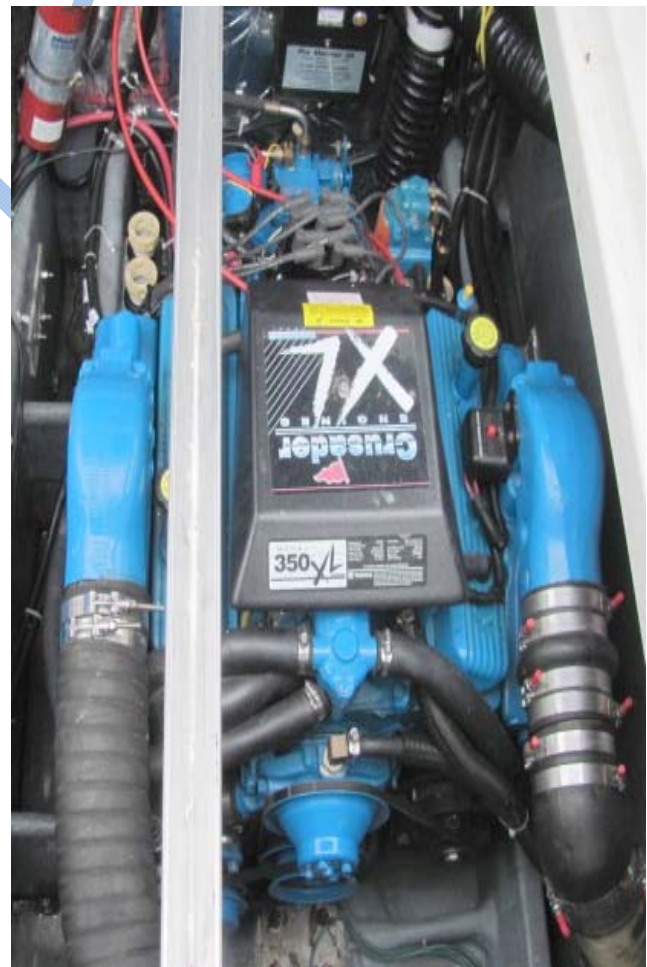
Starboard engine

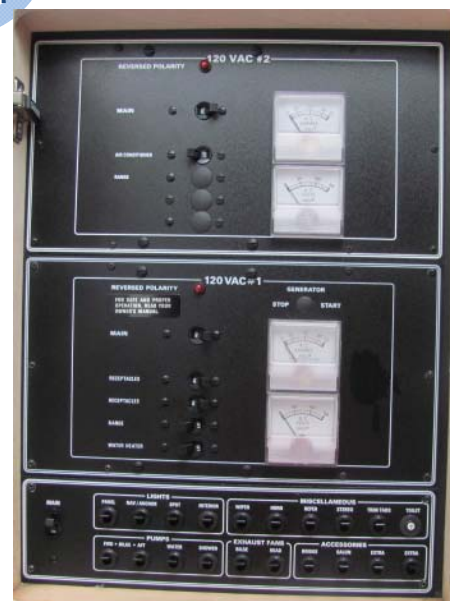
AC panel : Original equipment type panel with single pole main breakers, polarity indicator, volt meter, ammeter and accessory breakers in good visual order but sharing an enclosure with the DC system. **See comment (10).**

Shared DC & AC enclosure

- 8.** Repair or adjust plotter to show fish finder page.
- 10.** Transport Canada "Constructions Standards For Small Vessels", TP1332E requires AC and DC distribution systems not share the same panel board and if both systems share a common enclosure must have a means of clearly separating the two systems with a dielectric barrier.

- ABYC "AC and DC Electrical Systems on Boats", Standard E-11 permits AC and DC to share the same panel but requires that access to energized parts of the AC side need further use of tools.

- Ensure that such separation is fitted.
- 12b.** The current battery configuration uses both batteries for starting and house supply purposes. At anchor this configuration could leave the vessel without power in a very few hours. Consideration should be given to adding a third and isolated "house" battery.

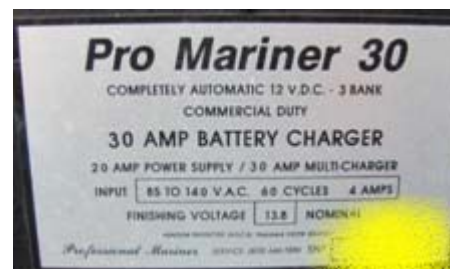
Ignition Protection : The battery charger is marked "Ignition Protected" but is not certified buy a third party laboratory as required. **See comment (9).**

Charger without certification

9. Transport Canada TP1332E requires that all electrical equipment in a compartment containing gasoline must be certified by a product certification body or a testing laboratory as being in accordance with *SAE J1171 External Ignition Protection of Marine Electrical Devices* and/or *UL 1500 Ignition Protection Test for Marine Products*. Although this charger is marked as "Ignition Protected" it does not carry the certification required by Transport Canada or USCG.

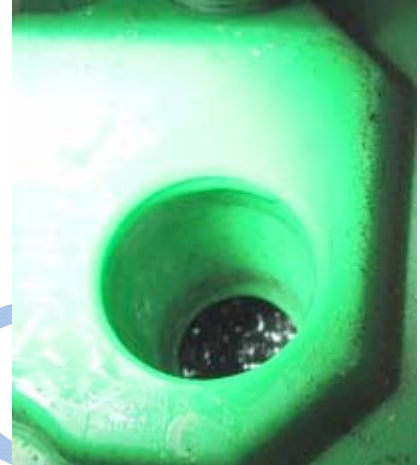
Exposed battery plates

- 12a. ABYC "Storage Batteries" Standard E-10 and TP1332E require in part that positive terminals be protected by dielectric material and prohibits wing nuts as a means of securing conductors 6AWG and larger.

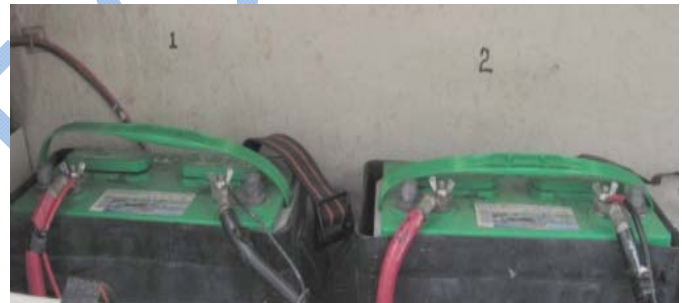
Batteries 1 and 2

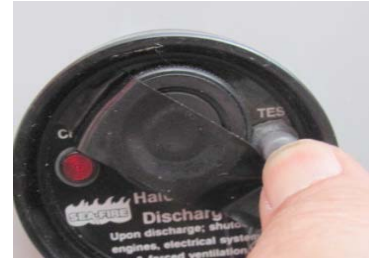
Fixed fire fighting system : A Halon 1301 system in the engine compartment is marked as not being inspected since 2004. The control panel TEST button at the helm did not engage the TEST light and part of the control is covered with electrical tape. **See comment (16).**

Fire extinguisher control with unresponsive indicator

16. ABYC "Fire fighting Equipment" Standard A-4 and NFPA 302 "Fire Protection Standard for Pleasure and Commercial Motor Craft" in part require that fire extinguishers and fixed fire fighting systems be inspected annually and carry tags indicating date of inspection.

Repair fire extinguisher control panel test button as required.

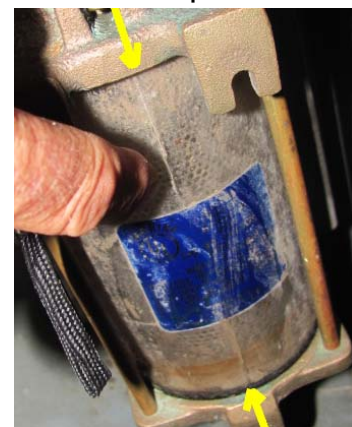
1. Metal transom drain with threaded insert appears sound.
2. Engine intake. Metal lever activated ball valve, double clamped and stiff in operation.
3. Engine intake. Metal lever activated ball valve, double clamped and free moving.
4. a/c intake. Metal lever activated ball valve, double clamped and free moving but the clear plastic strainer cylinder is cracked from top to bottom.

Cracked strainer cylinder

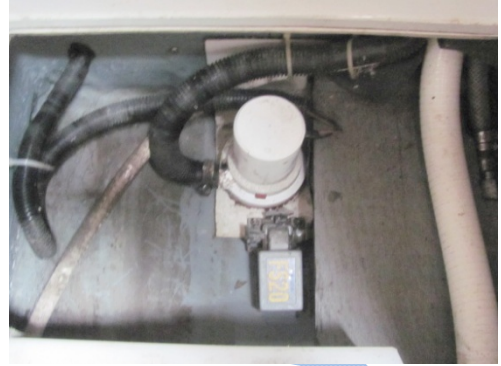
Bilges in accommodation spaces are generally clean with a small amount of bilge water that could be due to the cracked a/c strainer cylinder or the dripping stuffing boxes previously mentioned..

Accommodation space bilge
