# Marine Survey Report

Report Number :	2013P/2850				
Date of Inspection :	May 20 and 21, 2013. Title page photo May 17, 2013				
Commissioned by :	for pre-purchase purposes				
Address :					
e-mail :	mail.com				
Phone :

Marketed as a "Sundowner 30" in the USA, this vessel was built in Taiwan and rebranded as Regency by a Canadian importer. She is a standard production tug style vessel and diesel fueled and has galley, head compartment and sleeping quarters for four crew. Ontario license numbers are displayed at both bows. The HIN/MIC is clearly moulded in the upper starboard transom.

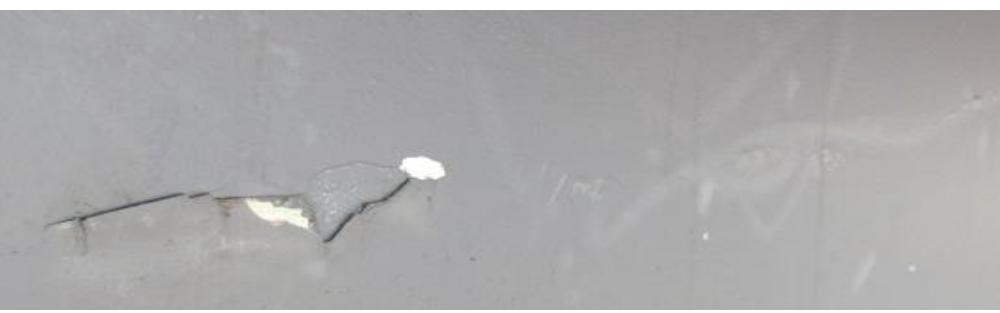
The keel checks sound and shows variable moisture levels on exterior surfaces from low to high. The starboard side of the keel shows some flaking gelcoat which reveals more gelcoat underneath and hairline fractures. See comment (2).

Flaking gelcoat on keel to starboard

- 1. Repair and re-finish wooden rub rail as required.
- 2. The hairline fractures in the gelcoat on keel and bottom are cosmetic issues and may be addressed if desired. The high moisture levels measured on the bottom exterior are likely due to a high capacitance paint under the VC17 anti-fouling paint as interior measurements showed low moisture levels.

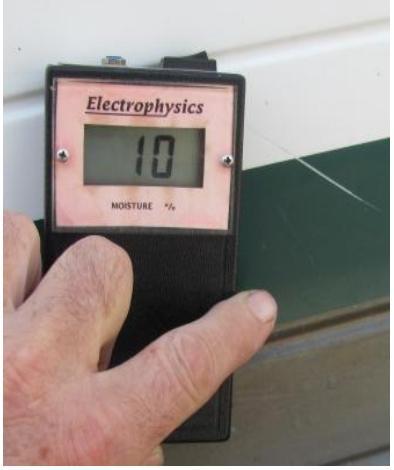
The transom checks sound with moisture levels in the low range above the waterline and high below.

Low moisture above waterline

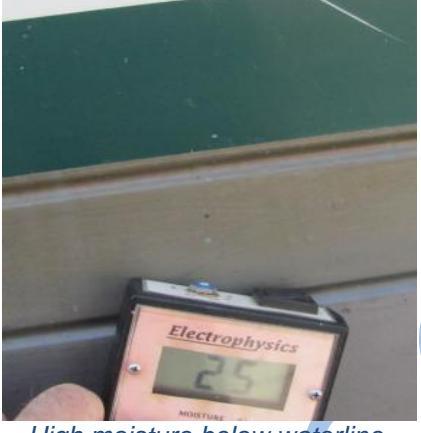
High moisture below waterline

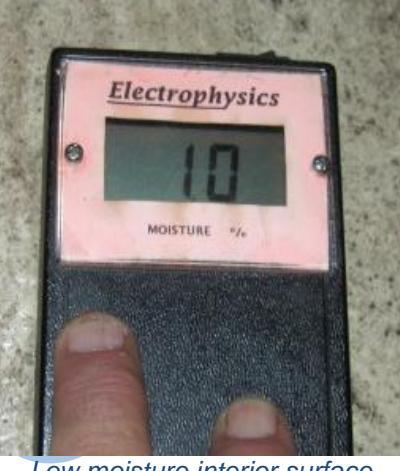
The bottom is fair and checks sound with moisture levels in the high range. On interior surfaces where accessible, moisture levels were in the low range. Multiple layers of antifouling paint are in satisfactory condition. Hairline fractures are noted near the starboard bow. **See comment (2)**.

Low moisture interior surface

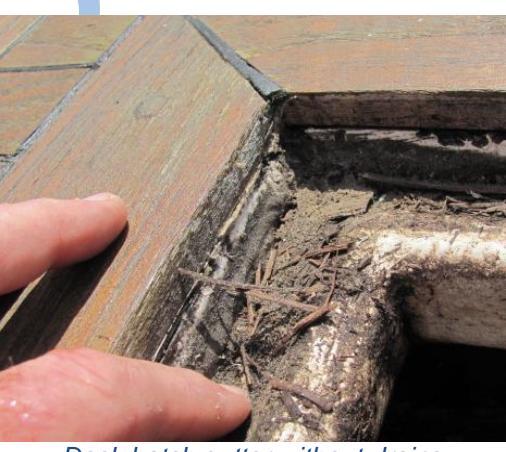
The main exterior decks are covered with teak planking in sound condition. Where accessible from the underside, moisture levels are high and soundings produce a dull report. The gutters around the lazarette hatch have no means of drainage and the deck core in this area is very soft with high moisture as is the hatch itself. **See comment (3).**

Deck hatch gutter without drains

- 3. The high moisture and dull checking on the underside of the decks and lazarette hatch pose no threat to the vessel or crew but do have a negative effect on value due to the high cost of repair.

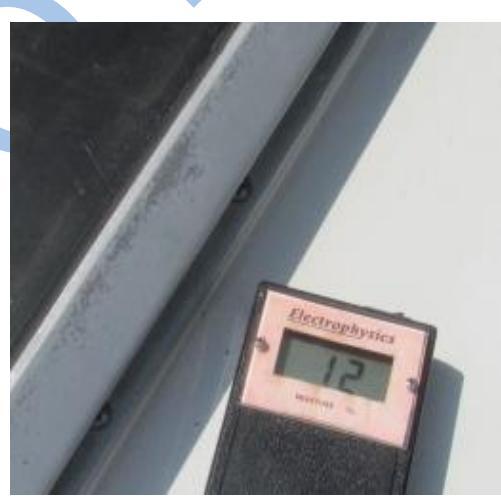
Superstructure : The deck house and pilot house show variable moisture from low to high but all surfaces are serviceably sound. The fore trunk shows low moisture levels. See comment (4).

Fore trunk low moisture

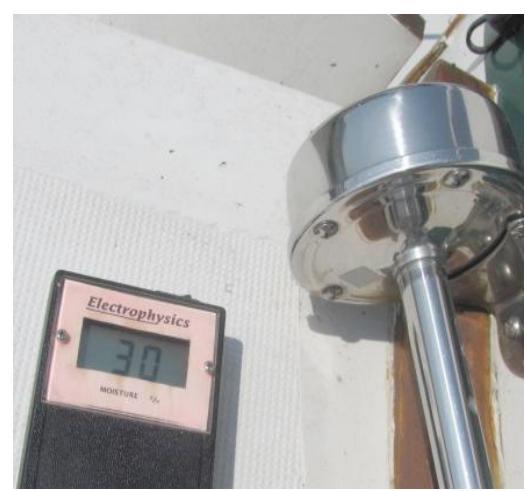
Pilot house deckhead -high moisture

- 4. The areas of high moisture on the deck house and pilot house pose no threat to vessel or crew as they are serviceably sound. . Re-bedding all fasteners and fittings may help extend the life of the core.

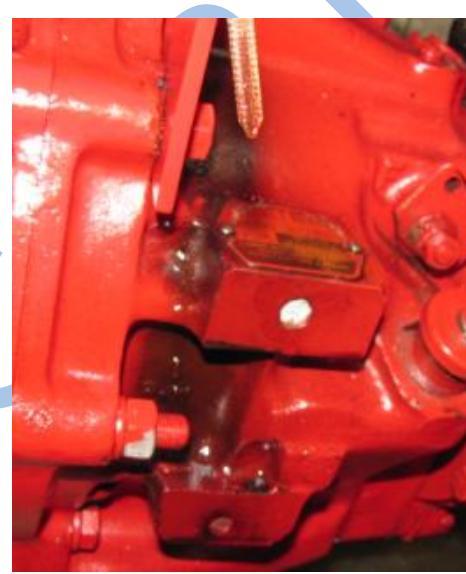
The engine in quite clean but for oil on the port side of the gear reduction unit. Engine oil, coolant and gear reduction fluid are clean and at proper levels. The bilges all have a few inches of water with an oily film. See comment (5a & b).

Oil on port side of gear reduction

- **5a.** Oil on the gear reduction unit appears to be coming from the bottom of the oil filter or filter housing. Additional oil was visibly leaking during the sea trial. This may be simply a poor gasket seal or oil hose union. It should be repaired prior to any voyage.
- 6. TP1332E and ABYC "Diesel Fuel Systems" Standard H-33 require a minimum ¼" air space be provided (when tank is full) between the tank and mounting surface and that the mounting surface be self draining in order to inhibit corrosion.

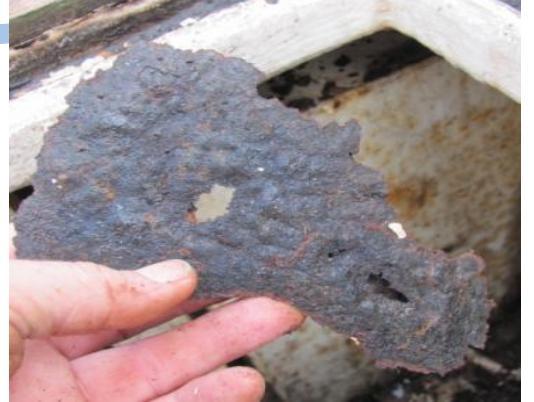
One steel tank is outboard on each side of the lazarette and both are mounted directly on wet plywood decks with an aluminum water tank in between. Wooden blocks directly on top of the tank are supporting the deck structure overhead. There is significant corrosion on the top of both tanks and severe corrosion on the bottom surface along the accessible aft 4". It is also likely that both tanks may be in direct contact with the aluminum water tank where galvanic corrosion should be expected. See comment (6).

Corrosion peeled from top of port tank

The corrosion on these tanks is severe where accessible and likely more severe on the inaccessible surfaces in contact with the wet plywood decks. Integrity of these tanks is suspect.

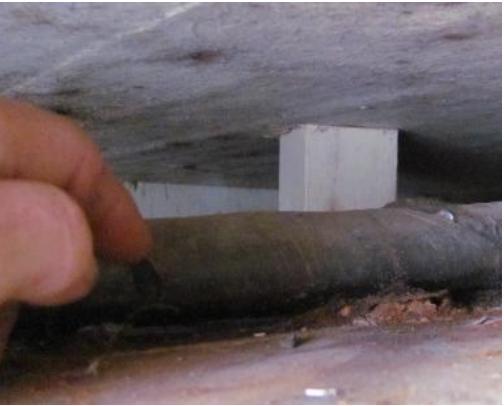
Deck support on fuel tank

H-33 also prohibits the use of the tanks as a means of support for decks unless they are specifically designed to do so. These wooden blocks do not appear part of any design.

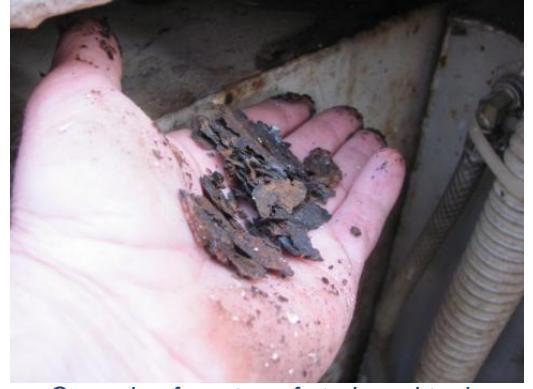
Corrosion from top of starboard tank

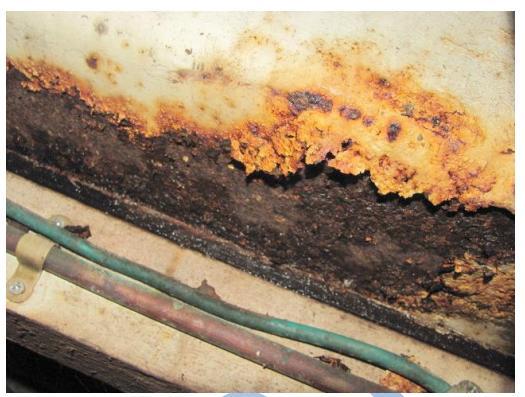
Accessible 4" of underside of port tank

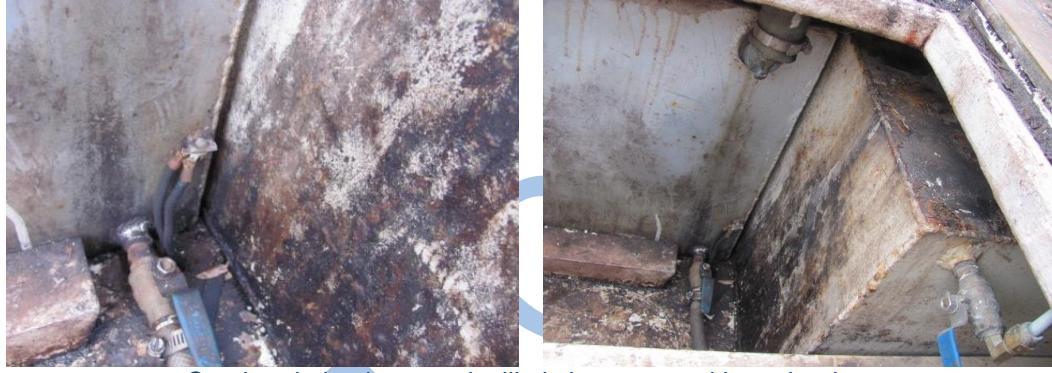
Steel and aluminum tanks likely in contact with each other

H-33 also requires metallic fuel tanks be installed so that water will drain from the top surface of the tanks and that metallic tanks be insulated from any other metal to avoid galvanic corrosion.

These tanks may be in contact with the aluminum water tank and if not in direct contact their corrosion by products most certainly are, making both metals susceptible to galvanic corrosion.

- 23. This aluminum water tank sitting on a wet plywood deck is prone to pitting corrosion and likely galvanic corrosion due to its contact with oxides from the fuel tanks. Integrity of the tank is suspect.

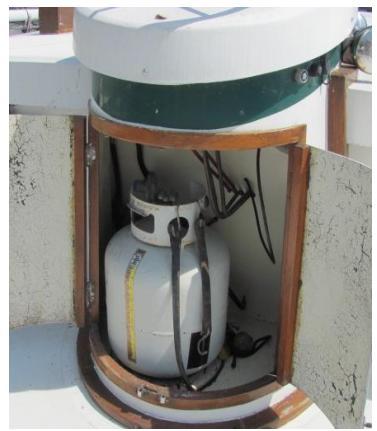
A galley stove is propane fueled and supplied from an expired propane bottle stored in a side loading, dedicated locker without direct overboard drainage or pressure gauge as required. The locker also contains a non-ignition protected engine ignition relay. The propane stove is not fitted with flame failure devices (thermocouples) and the fuel supply line is not accessible for inspection. **See comment (10).**

Side loading propane locker

- 10. NFPA-302 and ABYC " Marine Liquefied Petroleum Gas (LPG) Systems" Standard A-1 require that propane fuel bottles be stored securely in a dedicated, top loading locker with gasketed lid and direct overboard drainage with a minimum ½" inside diameter from the bottom of that locker and that the system be fitted with a pressure gauge. These same standards also require all appliances be fitted with flame failure devices (thermocouples). The propane tank certification has expired and the tank should be replaced.

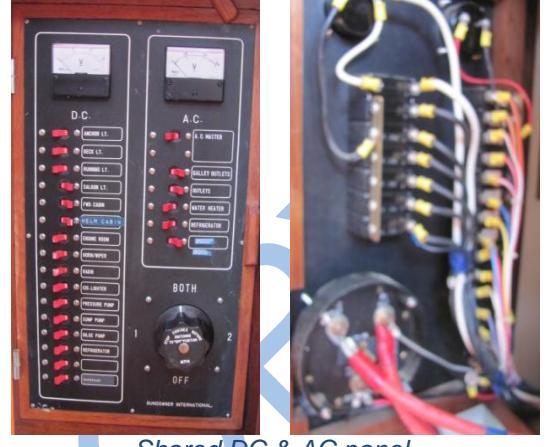
AC panel : Original equipment type panel with single pole main breaker, volt meter and accessory breakers in good visual order but sharing a panel with the DC system without AC/DC separation and without a polarity indicator. See comment (16a & b).

Shared DC & AC panel

- **11.** Repair all navigation lights as required.
- **16a.** Transport Canada "Constructions Standards For Small Vessels", TP1332E requires conformance with ABYC "AC and DC Electrical Systems On Boats" Standard E-11 which in part requires that AC panels be fitted with a double pole main circuit breaker or a single pole breaker and polarity indicator.

- **14.** Repair or replace depth sounder as required.
- **15.** Replace wiper blades.
- **16b.** Transport Canada "Constructions Standards For Small Vessels", TP1332E requires AC and DC distribution systems not share the same panel board and if both systems share a common enclosure must have a means of clearly separating the two systems with a dielectric barrier.

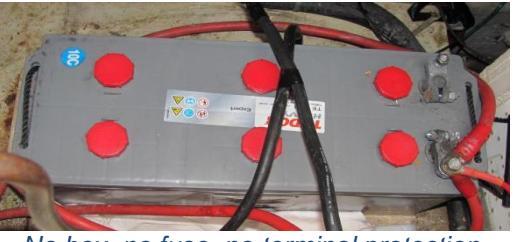
Two sealed 12VDC, 140amp/hr, one is in an FRP box with lid and one is not in a box, has no means of securement, no positive terminal protection and the house battery has no fuse protection. See comment (20).

No box, no fuse, no terminal protection

- 20. ABYC "Storage Batteries" Standard E-10 and TP1332E require in part that batteries not move more than one inch in any direction, be contained in boxes or trays resistant to electrolyte, that positive terminals be protected by dielectric material and requires positive conductors be fused within 7" of the battery or 40" if the conductor is fully enclosed with the exception of the conductor running to the engine starter motor.
