# Marine Survey Report

Report Number :	2013P/2850				
Date of Inspection :	May 20 and 21, 2013. Title page photo May 17, 2013				
Commissioned by :	for pre-purchase purposes				
Address :					
e-mail :	mail.com				
Phone :

Marketed as a "Sundowner 30" in the USA, this vessel was built in Taiwan and rebranded as Regency by a Canadian importer. She is a standard production tug style vessel and diesel fueled and has galley, head compartment and sleeping quarters for four crew. Ontario license numbers are displayed at both bows. The HIN/MIC is clearly moulded in the upper starboard transom.

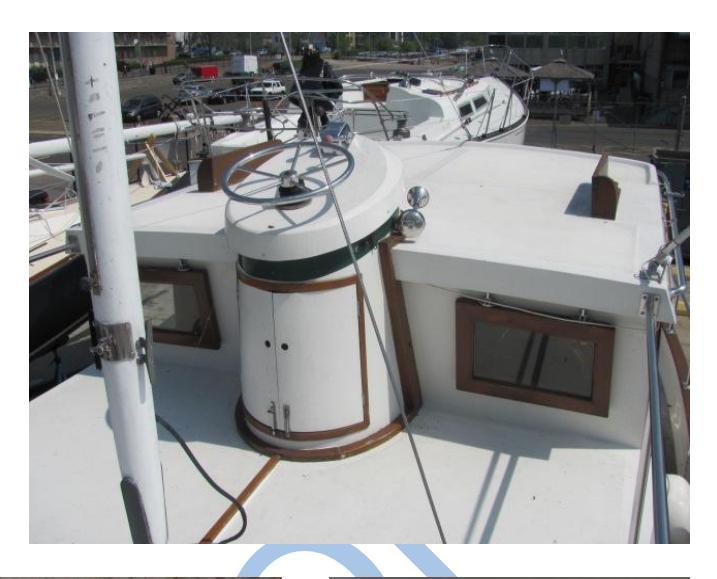
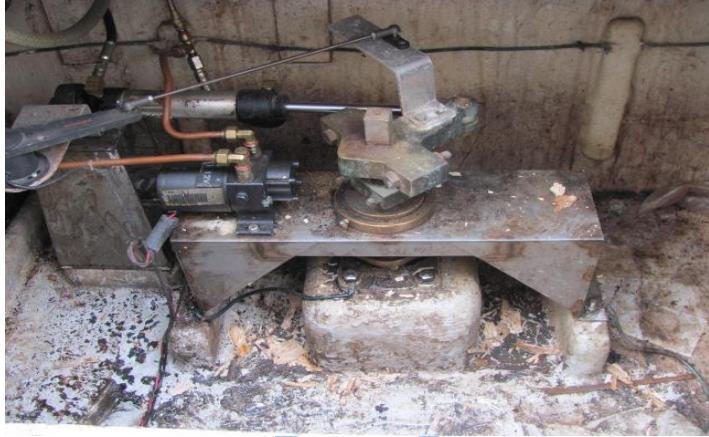
Hydraulic steering gear

- Steering : Wagner single ran hydraulic steering is secure and responsive at both stations.
- Rudders : Stainless steel plate rudder is sound and secure.

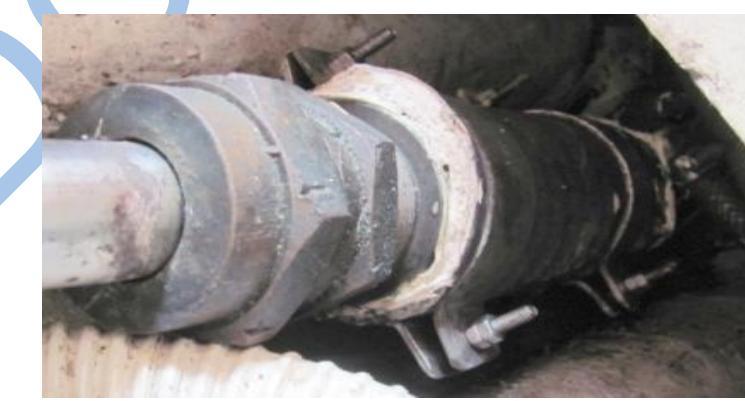
Stuffing box

- **Propeller :** One 3-blade bronze unit in good order and secured with nut, jam nut and cotter pin. Pitch and diameter are not legible.
- Shafting : A stainless steel shaft is secured through bronze log with cutless bearing to bronze logs to compression type stuffing box and conventional flange and all are secure and in good order.

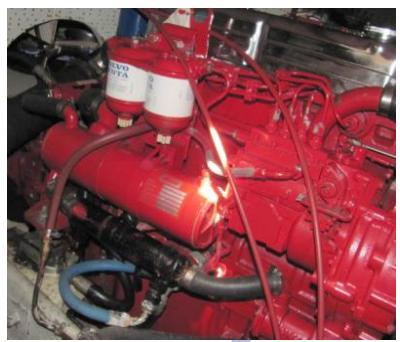
Engine from starboard

Engine mfg. :	Lehman			
Engine model :	SP90			
Engine type :	Naturally aspirated			
Engine serial No. :				
Horse power :	90			
Engine hours :	2038.59 per meter			
Gear mfg. :	Borg Warner			
Gear mod. No. :	5C . 1701			
Gear Ser. No. :				
Gear ratio :	2.1:1

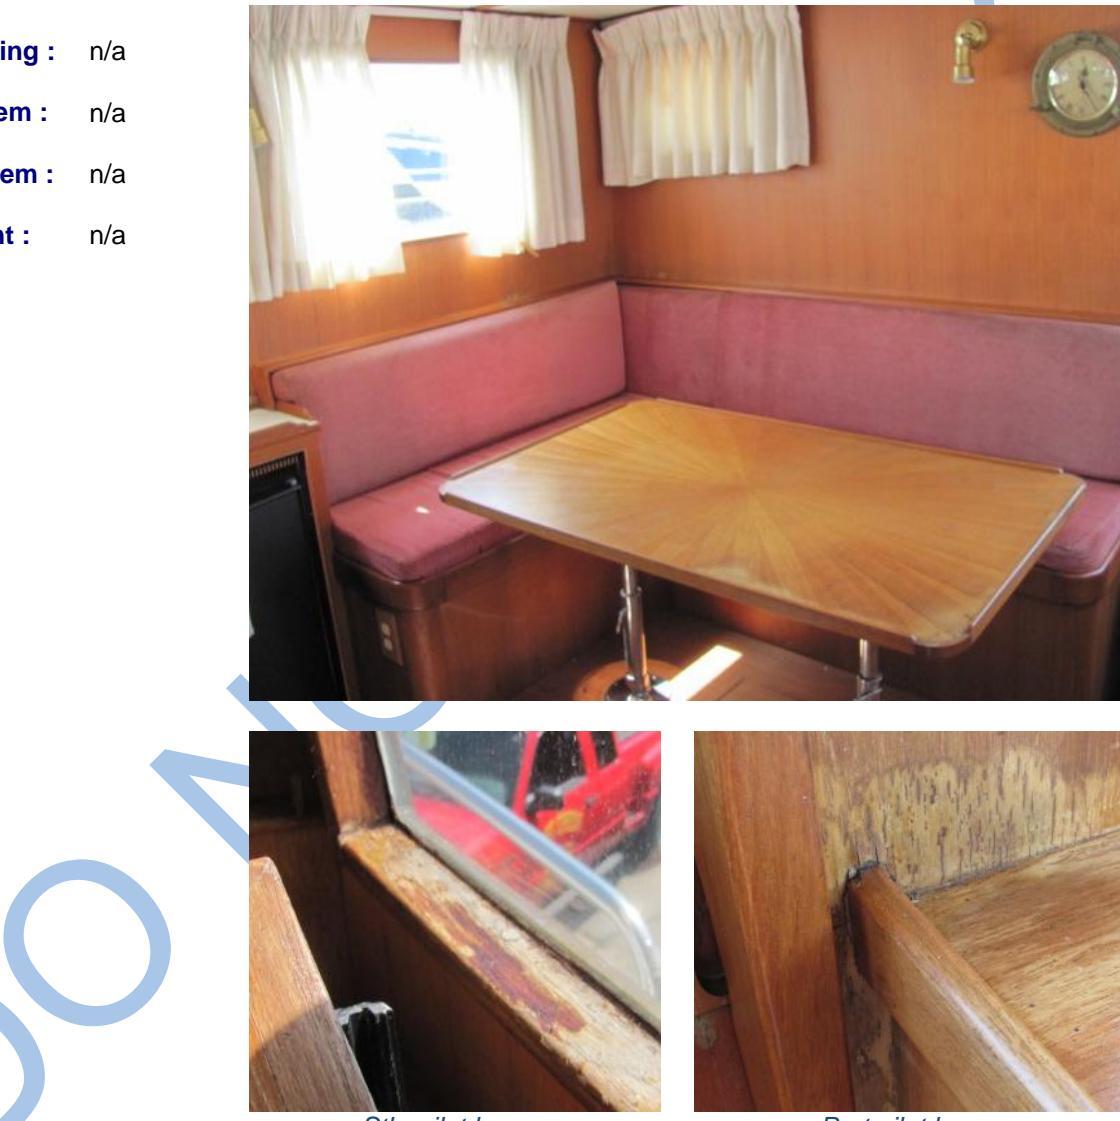
Stb. pilot house

Port pilot house
