Marine Survey Report

Report Number : 2013P/2883
Date of Inspection : July 3, 2013
Commissioned by : [redacted] for pre-purchase purposes
Address : [redacted]
e-mail : [redacted]
Phone : [redacted]

Make of Vessel : Carver 310 mid-cabin express

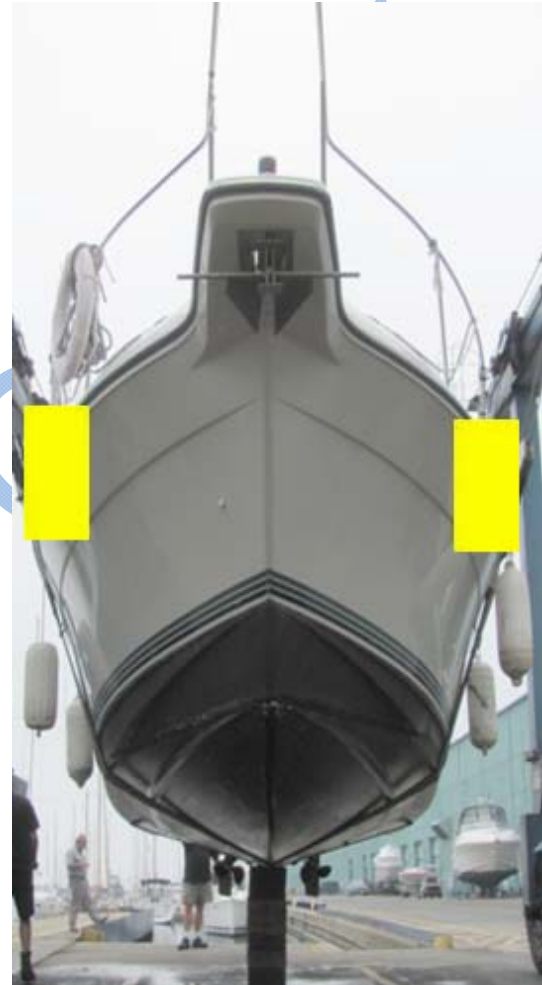
Bottom : The bottom is fair and checks sound. Moisture levels were not measured as the vessel had just been lifted from the water, in the low range. Multiple layers of antifouling paint are in poor condition with widespread flaking. **See comment (1).**

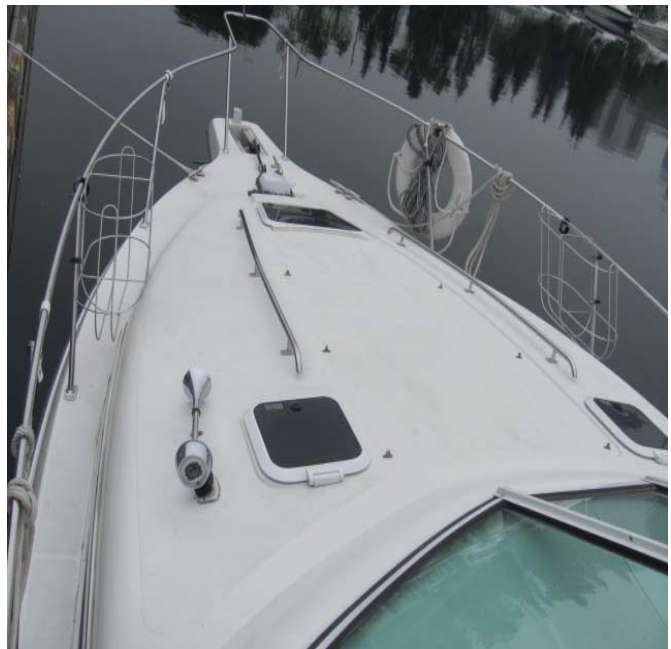
Stainless steel bow pulpit and side rails with twin fender racks are secure as are bow, midship and stern mooring cleats. An integral bow platform with single anchor roller is sound and in good order. On the trunk are stainless steel grab rails, an escape hatch, two ventilation hatches and all are secure and in good order but for the insecure 12VDC horn trumpet. **See comment (3).**

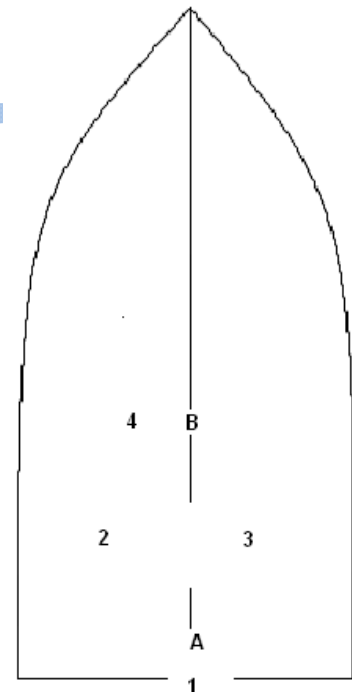
1. Metal transom drain with threaded insert appears sound.
2. Engine intake. Metal lever activated ball valve, double clamped and stiff in operation.
3. Engine intake. Metal lever activated ball valve, double clamped and free moving.
4. a/c intake. Metal lever activated ball valve, double clamped and free moving but the clear plastic strainer cylinder is cracked from top to bottom.

Cracked strainer cylinder

4. Stuffing boxes – re-pack or adjust as required.
- 12b. These batteries must be considered unreliable. Load test to confirm condition or replace.
- 17b. Close a/c intake ball valve and replace clear plastic strainer cylinder.
